Manhole Inspection Summary

Manhole # S23K__020MH

Insp Date: **6/10/08 10:22 AM**

Location Address: **301 S Gilmore St**

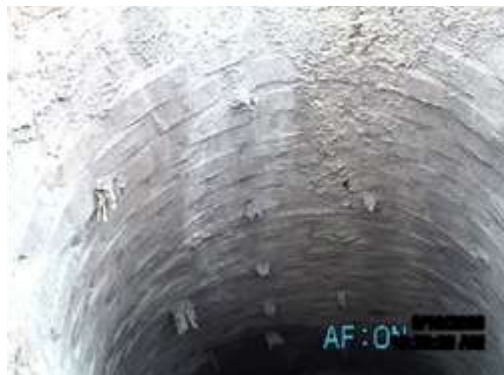
Defect 7

Count: **6** Missing: **6** ☒ **Corroded**

missing all rungs

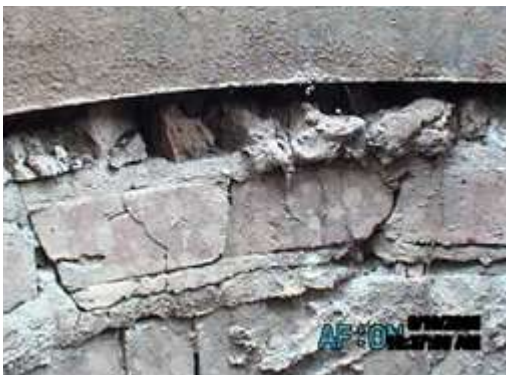
Defect 6

Condition: ☐ Sound ☒ **Cracked** ☐ Root Intrusion ☒ **Loose Brick** ☒ **Deteriorated**

Infiltration: ☐ None ☒ **Joint** ☐ Cracks ☒ **Mortar** ☐ Roots ☐ Wall

broken bricks missing mortar
frame-chimney joint infiltration

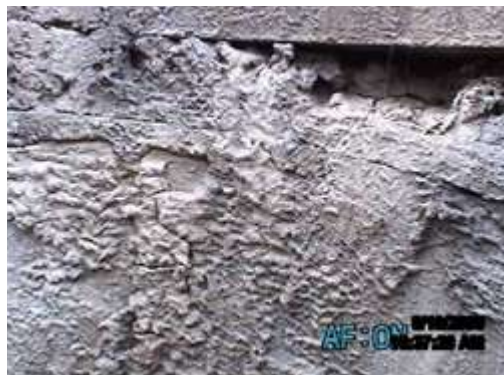
Defect 5

Condition: ☐ Sound ☐ Cracked ☒ **Leaks**

infiltration frame-chimney as well as frame
-lid

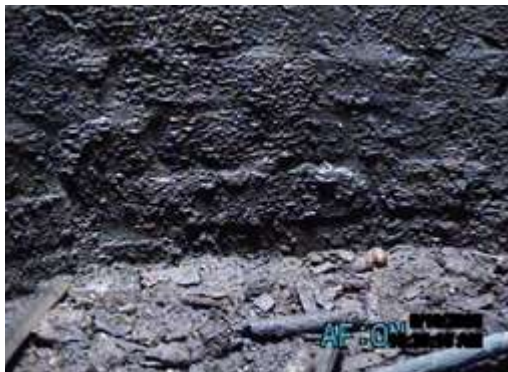
Defect 2

Condition: ☐ Sound ☐ Cracked ☐ Root Intrusion ☐ Deteriorated ☐ Leaks ☒ **Debris**

debris on bench and channel

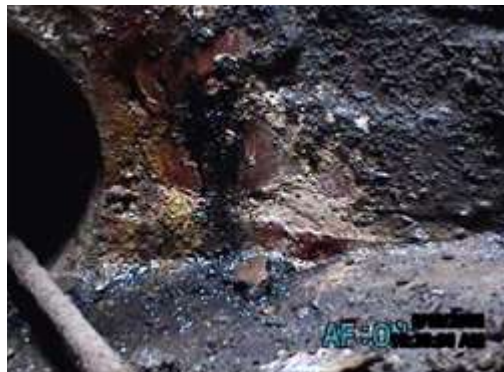
Defect 1

Condition: ☐ Sound ☐ Cracked ☐ Root Intrusion ☐ Loose Brick ☒ **Deteriorated**

Infiltration: ☐ None ☐ Joint ☐ Cracks ☐ Mortar ☐ Roots ☒ **Wall**

active infiltration barrel

Comments **For a better visual on wall defects cleaning needed.**
